PREVOST H3-40 AIR DISC BRAKE FAILURE AND REPAIR — PART 1 OF 3

BY BRUCE FAY

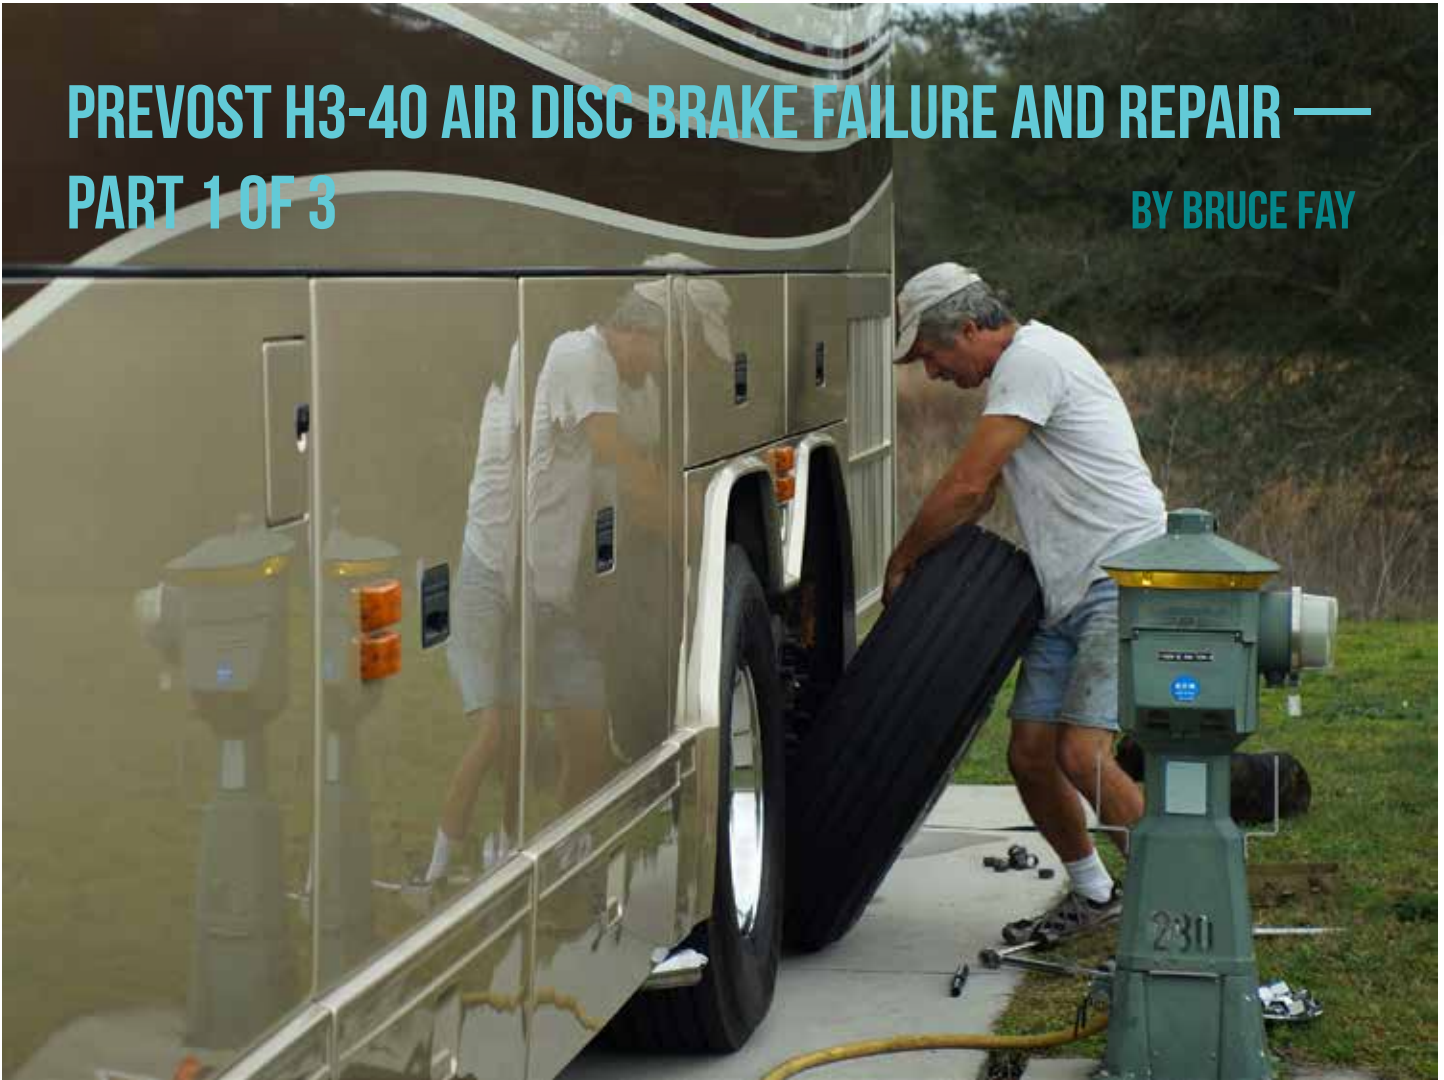
Mobile chassis mechanic, Joe Cannarozzi, stopped by Florida Grande Motor Coach Resort on his way north from Ft. Lauderdale, FL. The tire/wheel combination is very heavy.
